LTB00557V10

TECHNICAL BULLETIN

204-00

Noise From Front Suspension

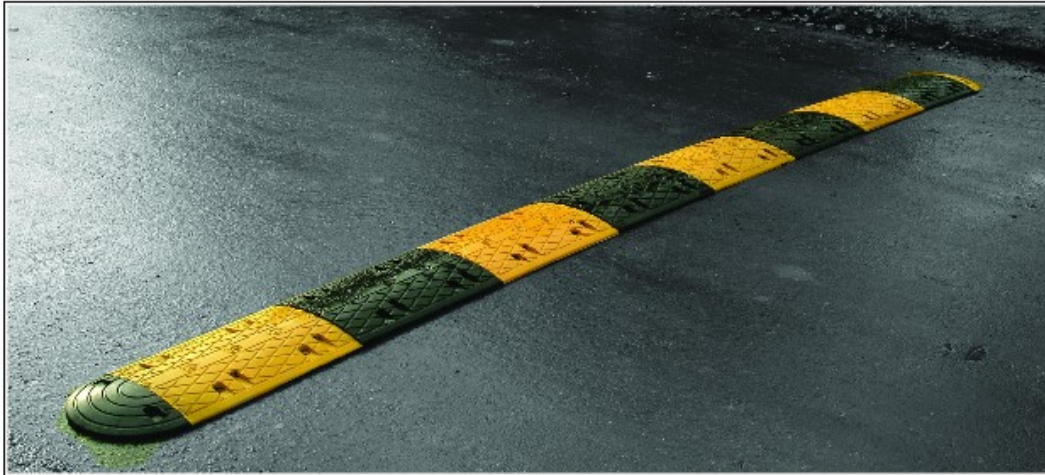
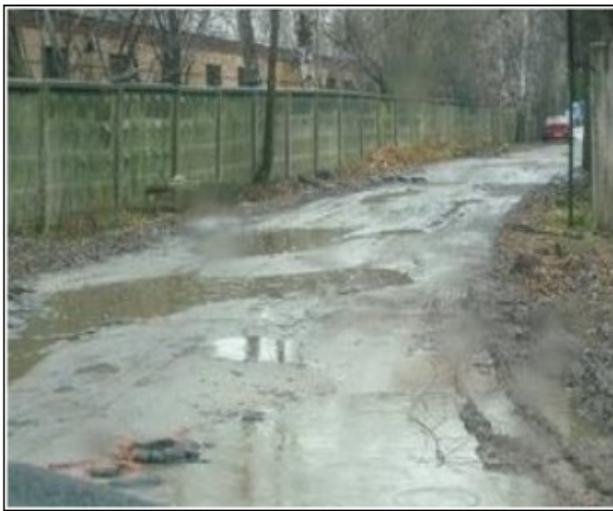
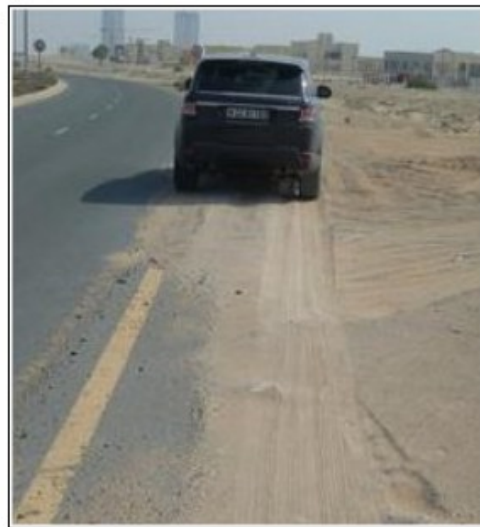
E162272

Symptom: Single knock OR a series of isolated knocks.

- **Drive Cycle/Conditions:** Single and dual wheel inputs from speed bumps/damaged road surfaces or similar. When traveling at speeds of up to 25mph (40kmh) ONLY when traveling in a forward direction.
 - **Actions: Complete Steps 1-24 in the service instruction.**
-

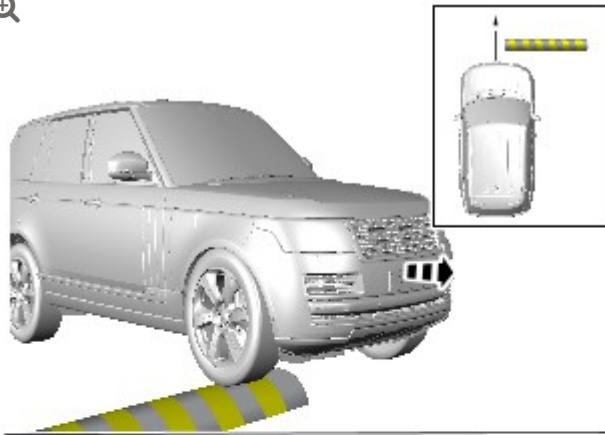
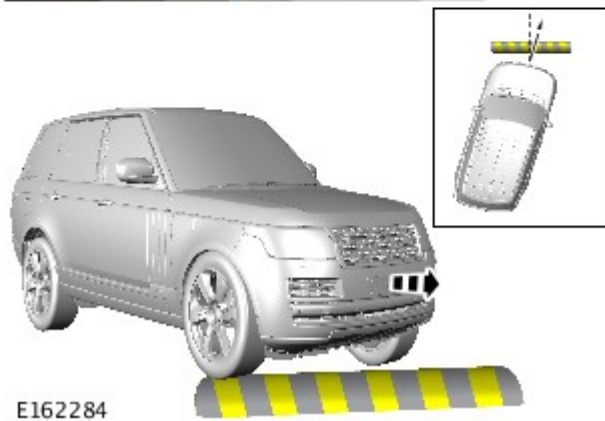
E162284

Symptom: Click Noise.

- **Drive Cycle / Conditions:** Click only occurs during: harsh cornering, rapid acceleration and abrupt braking.
 - **Actions:** Refer to technical bulletin LTB00618 – Click/rattle sound from engine mountings. If this does not solve the concern then remedial work may be required to the steering gear.
-

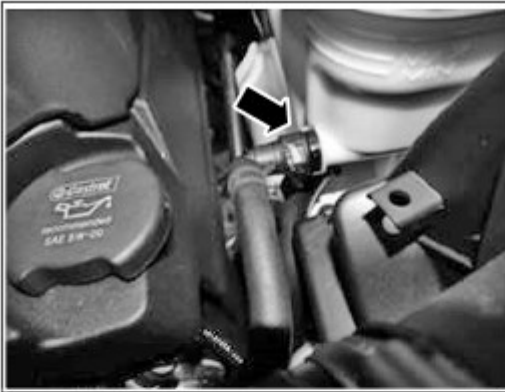
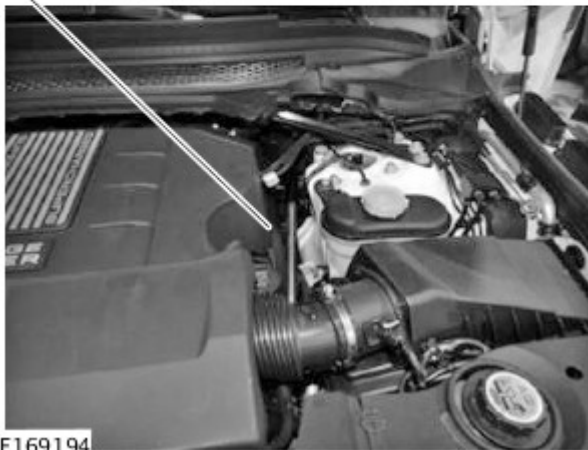
E169194

Inspect the Dynamic Response fluid reservoir for leaks.

- If a leak **IS** present, replace the dynamic response fluid reservoir (see TOPlx Workshop Manual section 204-06: Ride and handling optimization - Removal and installation - Fluid reservoir).
- If a leak **IS NOT** present, **continue to step 2.**

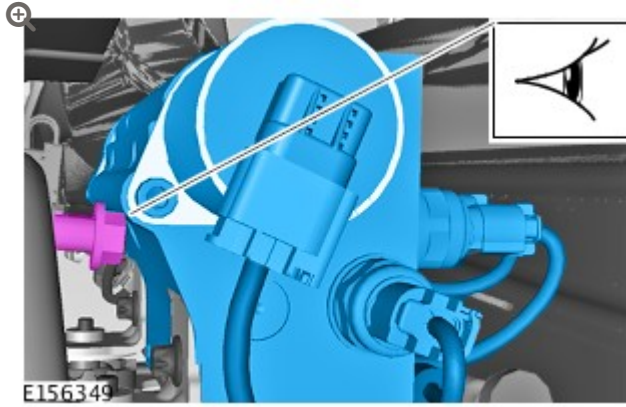
The view of the end of the hydraulic valve block from the front of the vehicle.

Inspect the valve block to body stud clearance.

- Sufficient clearance between the valve block body and the plastic body fastener that secures the fuel lines is required. Where no or very little clearance exists, modify the head of the fastener, **continue to step 9.**

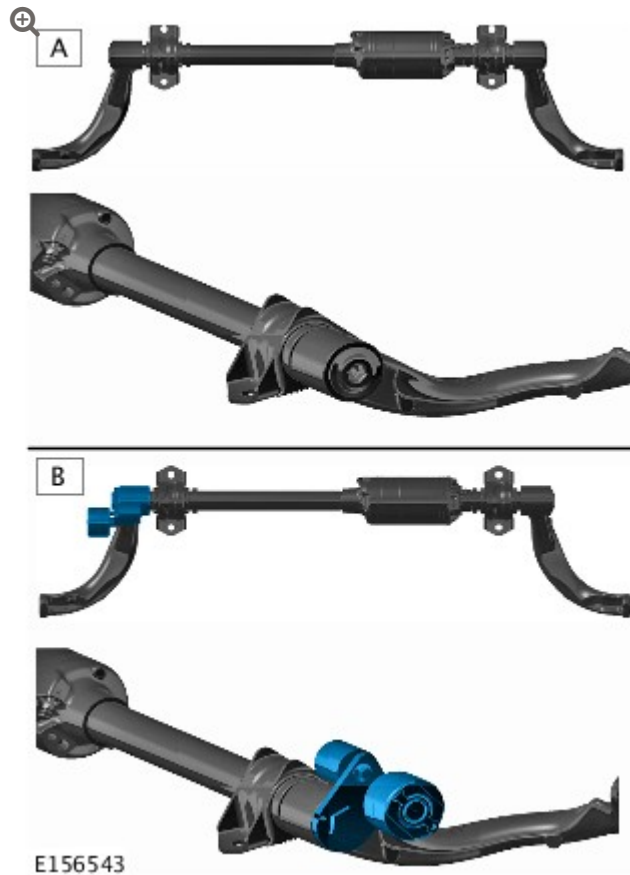
If the latest specification of front actuator bar is installed DO NOT replace it unless it is damaged/leaking fluid.

2013 Model Year (MY) vehicles: If the knocking noise is still present and considered unacceptable after performing the above steps, then replace the dynamic response front actuator (part number LR052058 shown as B in graphic E156543) (see TOPIx Workshop Manual section 204-06 Ride and Handling Optimisation - Front Stabilizer Bar). **2014 MY vehicles from VIN 125193:** will have the latest level parts already installed.

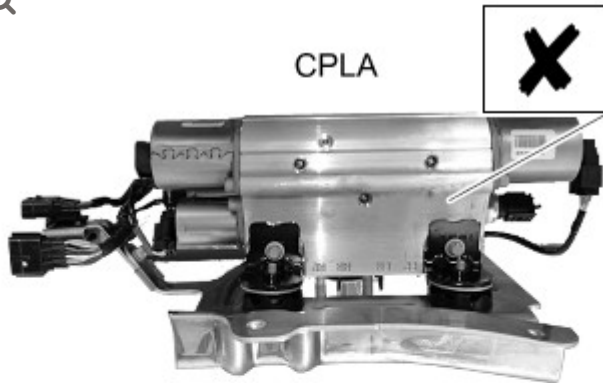
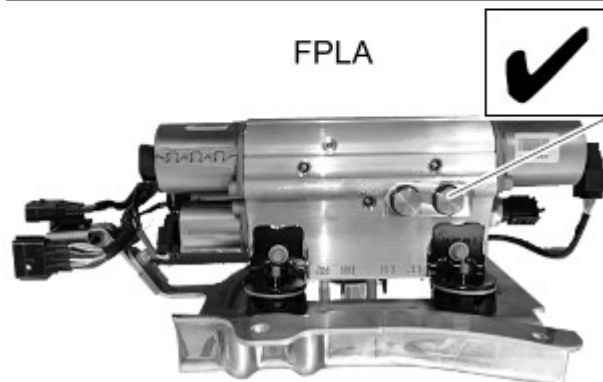
E166598

On a strong customer complaint, please confirm which level of valve block is installed:

For Identification purposes, the valve block is shown removed for clarity.

- If the vehicle **IS NOT** equipped with the latest level valve block, install a new valve block (see TOPlx Workshop Manual section 204-06: Ride and handling optimization - Removal and Installation - Valve block) and then **continue to step 14**.
- If the vehicle **IS** equipped with the latest level valve block, **continue to step 24**.
