TECHNICAL BULLETIN

LTB00504v3

Compressor Shut Off Valve (CSOV) Lower Level Repair

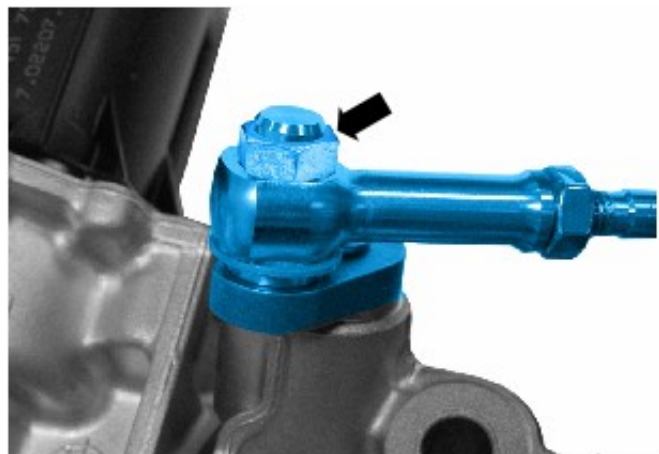
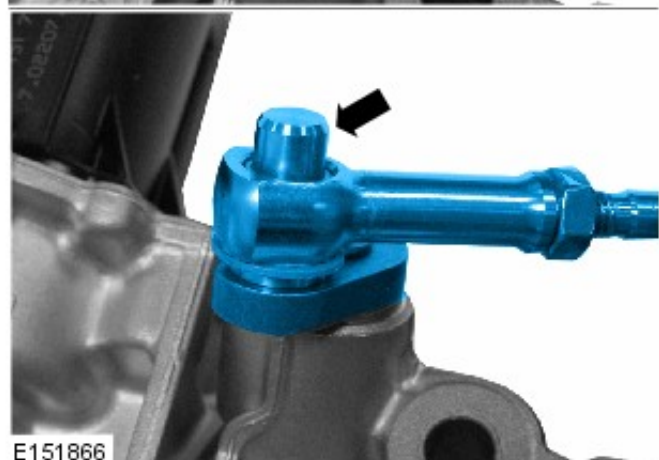
1. Carry out a visual check, this check can be carried out without the need to take the part off the vehicle. This inspection will help identify if the vehicle is already fitted with the latest CSOV/ had a previous repair. If this is the case this TSB would not apply.

1. In addition to the bush, the pin is now plain without the retention nut, if no retention nut is fitted as per lower graphic in E151866 the vehicle has the latest csov fitted with the latest level linkage arm and this TSB does not apply. This TSB only applies to CSOV assemblies with a retaining nut fitted on the link arm as shown in the upper graphic.
