## Oil Dilution on Jaguar Land Rover D8 diesel SUVs

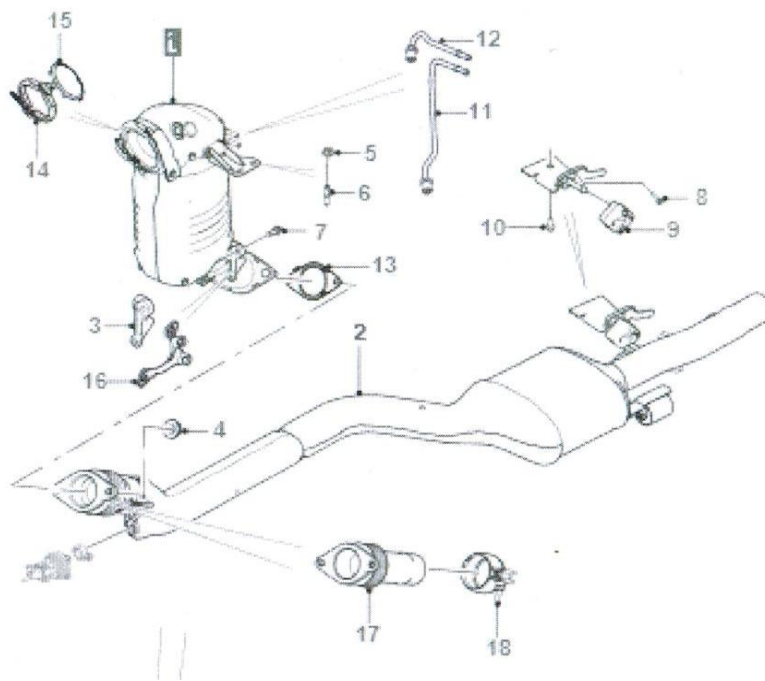
**Fig 1 – Jaguar XE Exhaust**

In the Jaguar XE parts schematic below the combined DOC-DPF is the vertical canister (1) which attaches to the Ingenium turbo outlet by clamp (14) and seal (15). DEF injection is made at bottom left under clamp (18) and the SCR consists of the horizontal pipe and canister (2).

The Jaguar XE X760 went on sale with this exhaust hardware and architecture in early 2015. The first sales recorded for the Jaguar XE were March (2), April (20) and May (624). The next vehicles scheduled to receive the Ingenium engine with EU6-compliant exhaust emissions after-treatment (mandatory for all new vehicles sold from 1<sup>st</sup> September 2015) would be the Discovery Sport L550 and Range Rover Evoque L538. Until August 2015 these cars were still being sold with a transversely-mounted EU5-compliant PSA/Ford Duratorq 2.2L diesel engine.

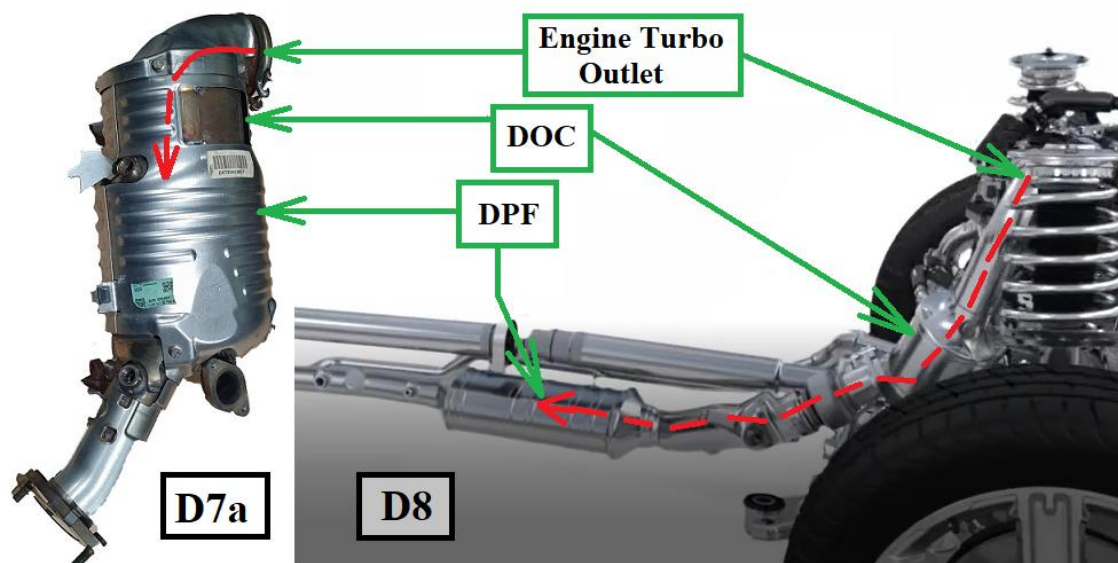
Fig 3. Jaguar Land Rover exhaust after-treatment architectures

The Jaguar XE oxidation catalyst and DPF are physically contained within a single canister so that virtually no heat loss occurs between the engine and the DPF. The DPF temperature remains high at all times and it requires very little additional heat to reach the temperature required for active regeneration to begin. On the D8 architecture there are two lengths of pipework separating the turbo outlet from the DOC and the DPF so heat losses are significant. The D8 vehicles require longer periods of active regeneration to heat up the DPF and maintain the temperatures required for active regeneration to continue. This is what is meant in JLRP00100 where it says that “*the duration / distance to complete a full regeneration on 2.0L diesel Evoque / Discovery Sport is longer than on 2.0L diesel Jaguar XE*”.
