Brake Pad and Brake Disc Fault Diagnosis

Technical information

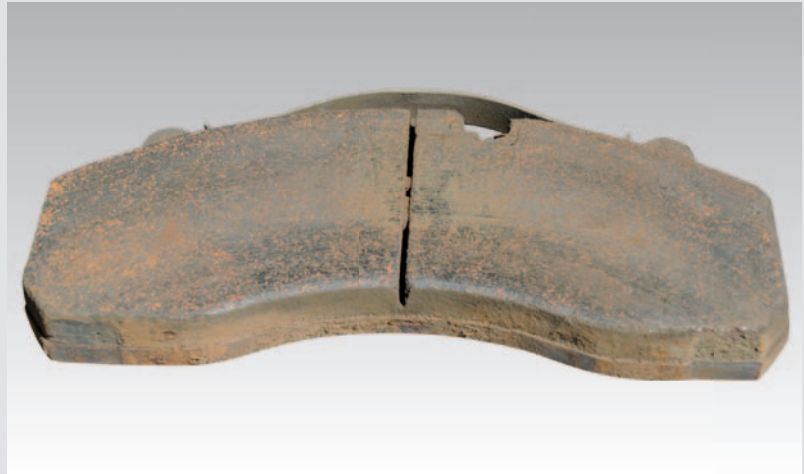
- Friction material decomposes, breaks off in some places and/or the underlayer and adhesive are damaged. Pad detaches completely; coating peels off. Partial colouring of the backing plate. Friction material has hardened, has a hard ring, reddish brown colouring of the friction material, white ash in some places.

Disc brake pads have exceeded the highest permissible temperature for longer than 15–20 minutes.

During this time, constituents that contribute significantly towards stability are destroyed.

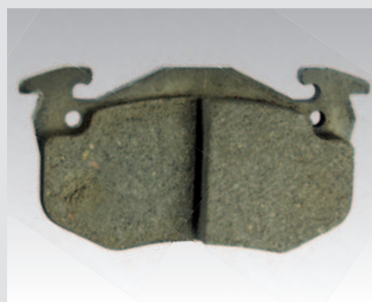
The friction material detaches from the backing plate. Delamination occurs. Disc brake pads are new, separation above the adhesive/underlayer. Damage visible on the backing plate.

Damage as a result of bending stress visible on the backing plate.

Disc brake pads have been dropped or fitted at a tilt or deformation due to extreme “wobbling” in the brake caliper.

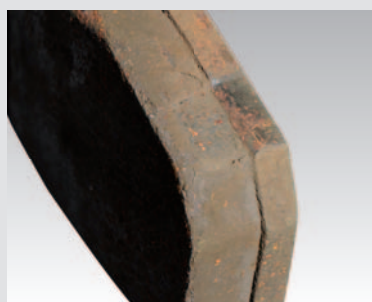
Excessive “wobbling” of the backing plate within the brake caliper.

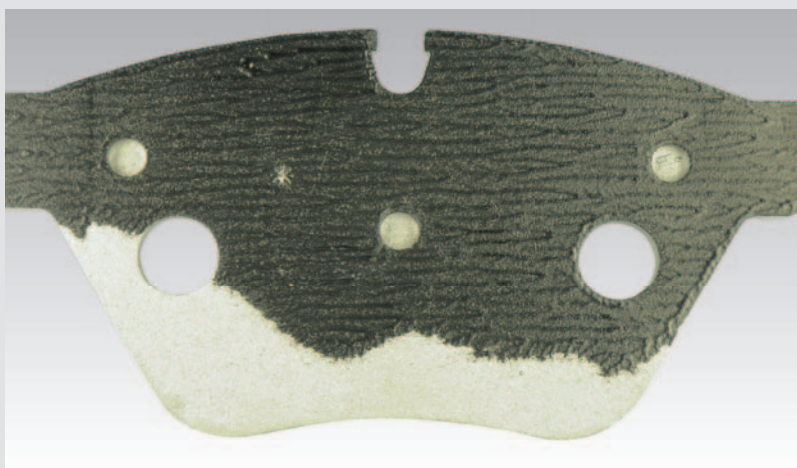
- ▶ Friction material has already become detached when subject to low stress. There is insufficient adhesive.

- Backing plate smooth or underlayer and adhesive only partially visible.
- Unsatisfactory adhesion. Underlayer improperly distributed.

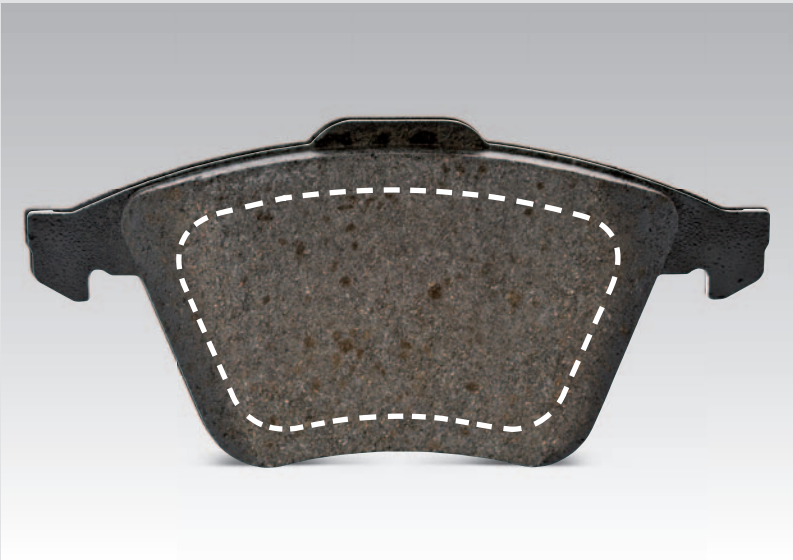
► Break-offs are permissible outside of the area marked, however, up to a maximum of 10% of the total pad surface.

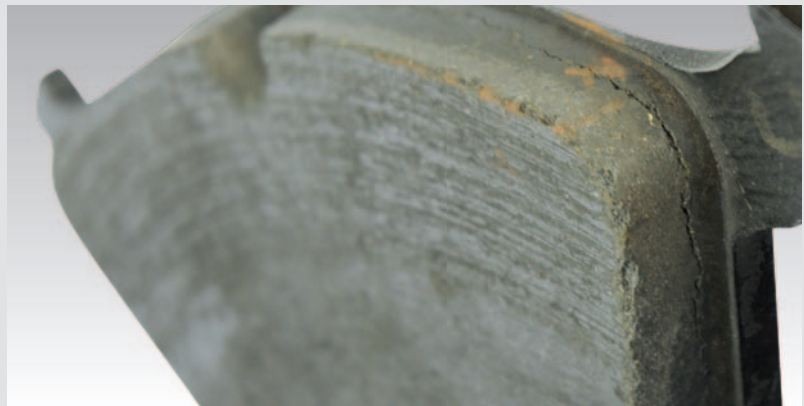
- ▶ Pad with inadmissible deterioration

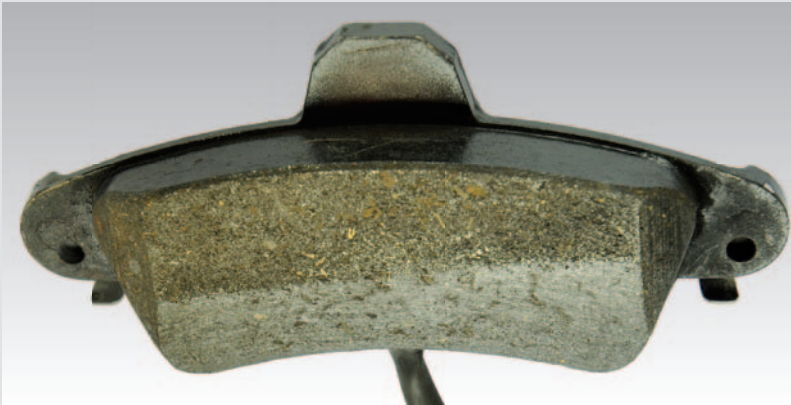
► Pad with inadequate contact pattern

- Worn or incorrect brake disc
- Brake defect/contamination
- Insufficient brake loading
- See also fitting faults/
production faults

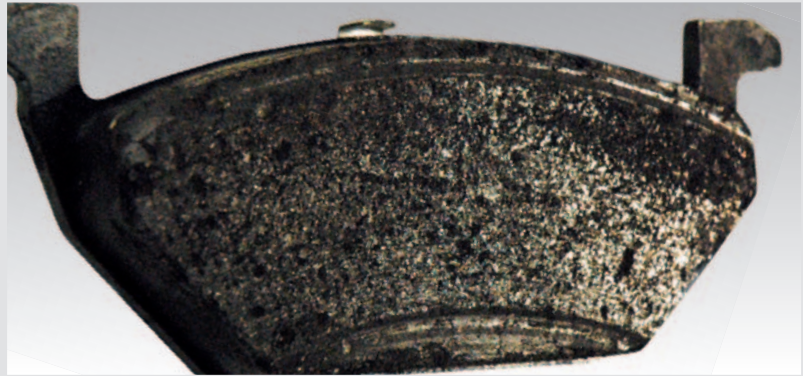
- ▶ Use of new brake pads on extremely scored/worn brake disc

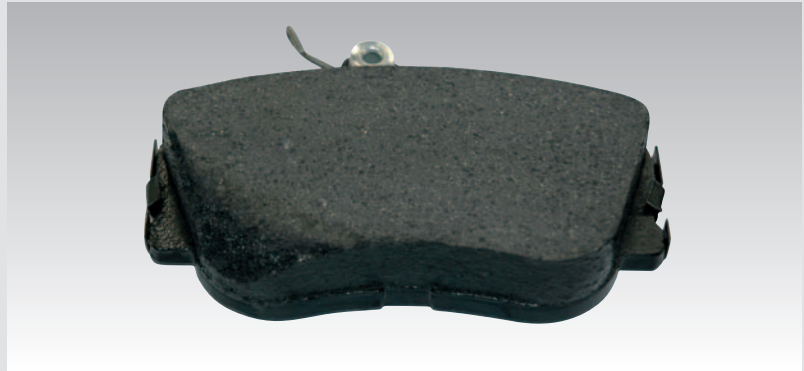
► Break-offs on the edges

Design-related pressing overhang to completely utilise the friction ring of the brake disc.

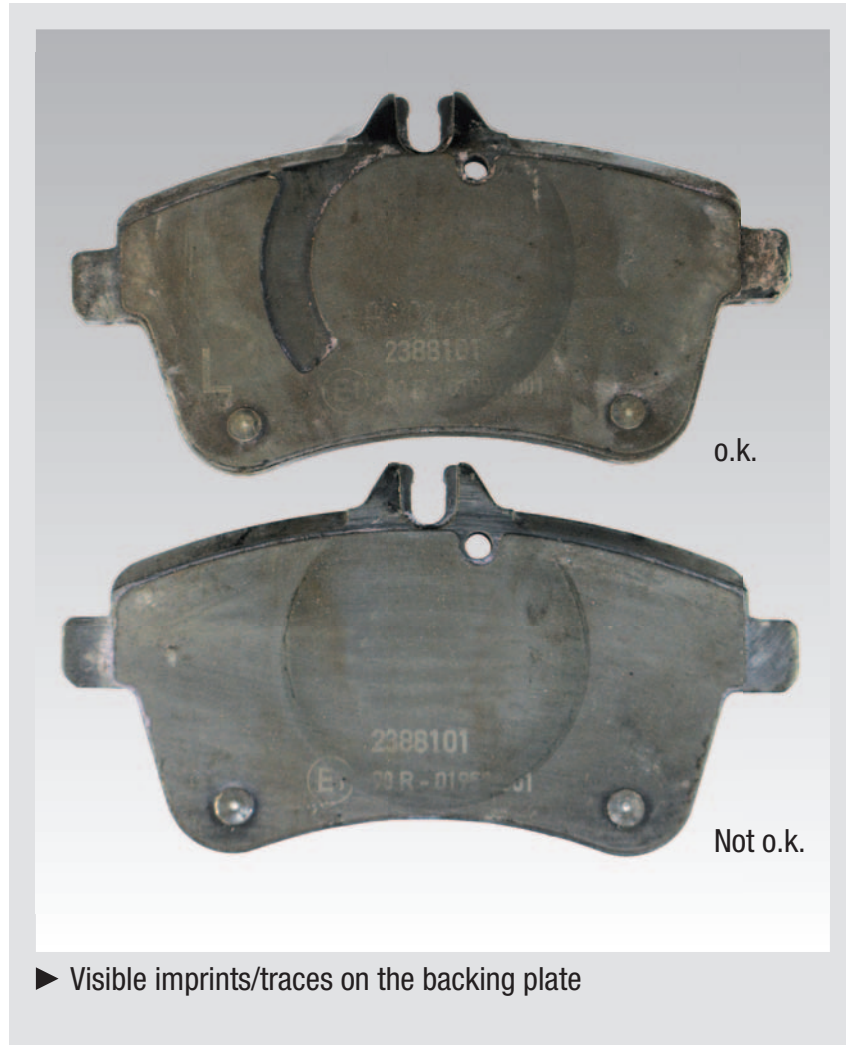
► Visible imprints/traces on the backing plate

Incorrect fitting position

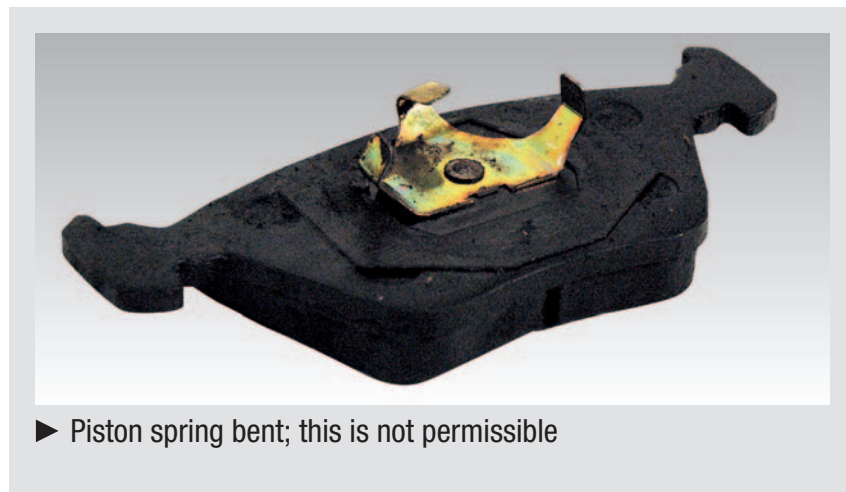
► Piston spring bent; this is not permissible

Improper handling prior to/during fitting

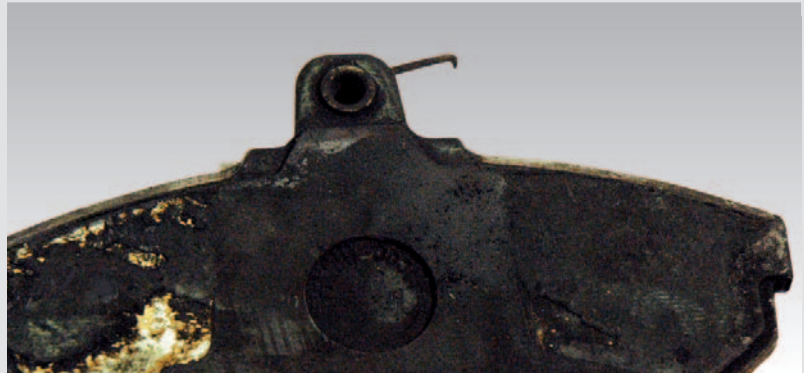
► Hold-down spring broken

The accessory is subject to use-related wear and, depending on the model type, is included in the scope of supply.

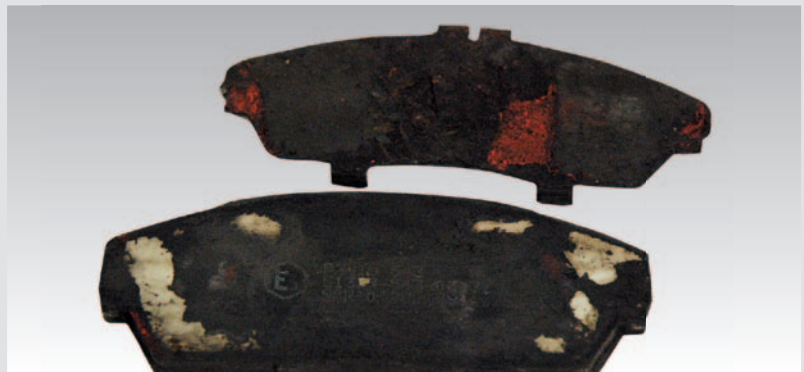
► Clip-on plates worn

Pay attention to correct seating in the caliper in order to ensure perfect functioning.

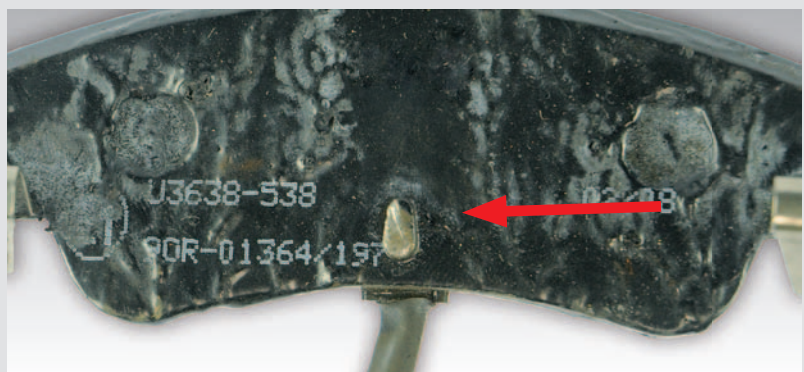
► Piston imprint on the positioning device

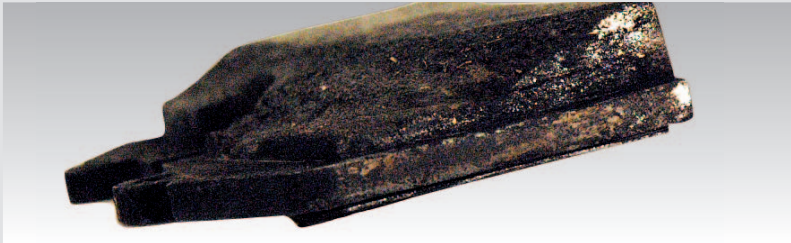
► Obvious damage due to external influence

Brake caliper not freed from contamination and corrosion.
Dimensional deviation of backing plate.

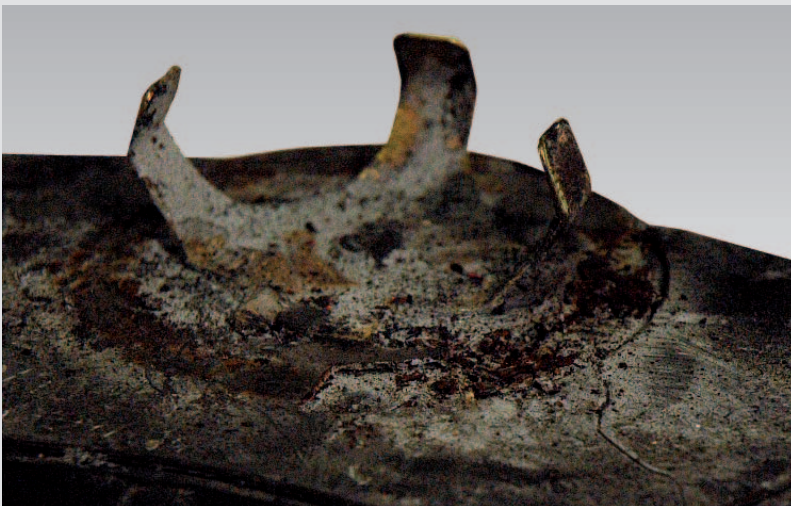
► Cut-out in the damping plate is not functioning due to contamination

Brake caliper not freed from contamination and corrosion;
excessive greasing.

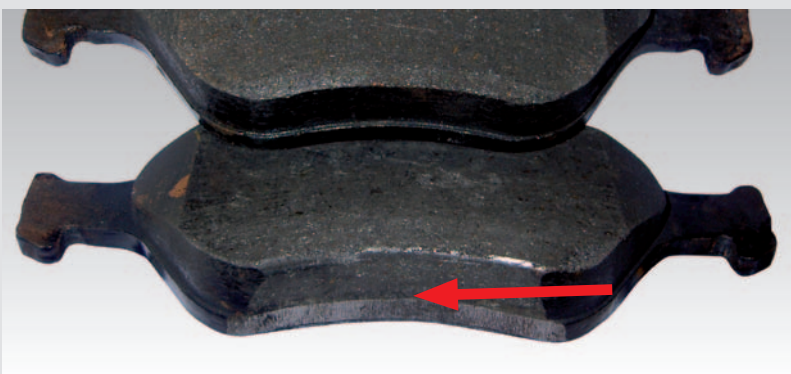
► Improperly changed pad geometry

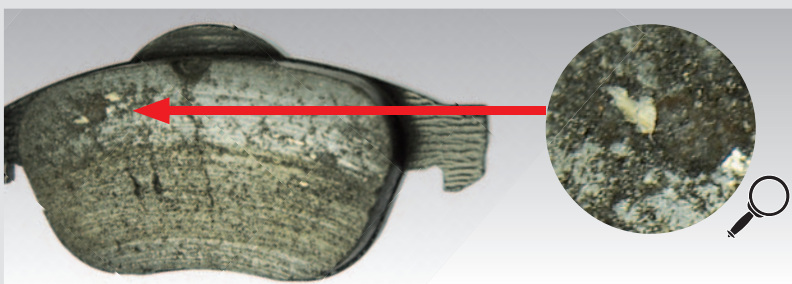
▶ Residues – metal pick-ups in the pad surface

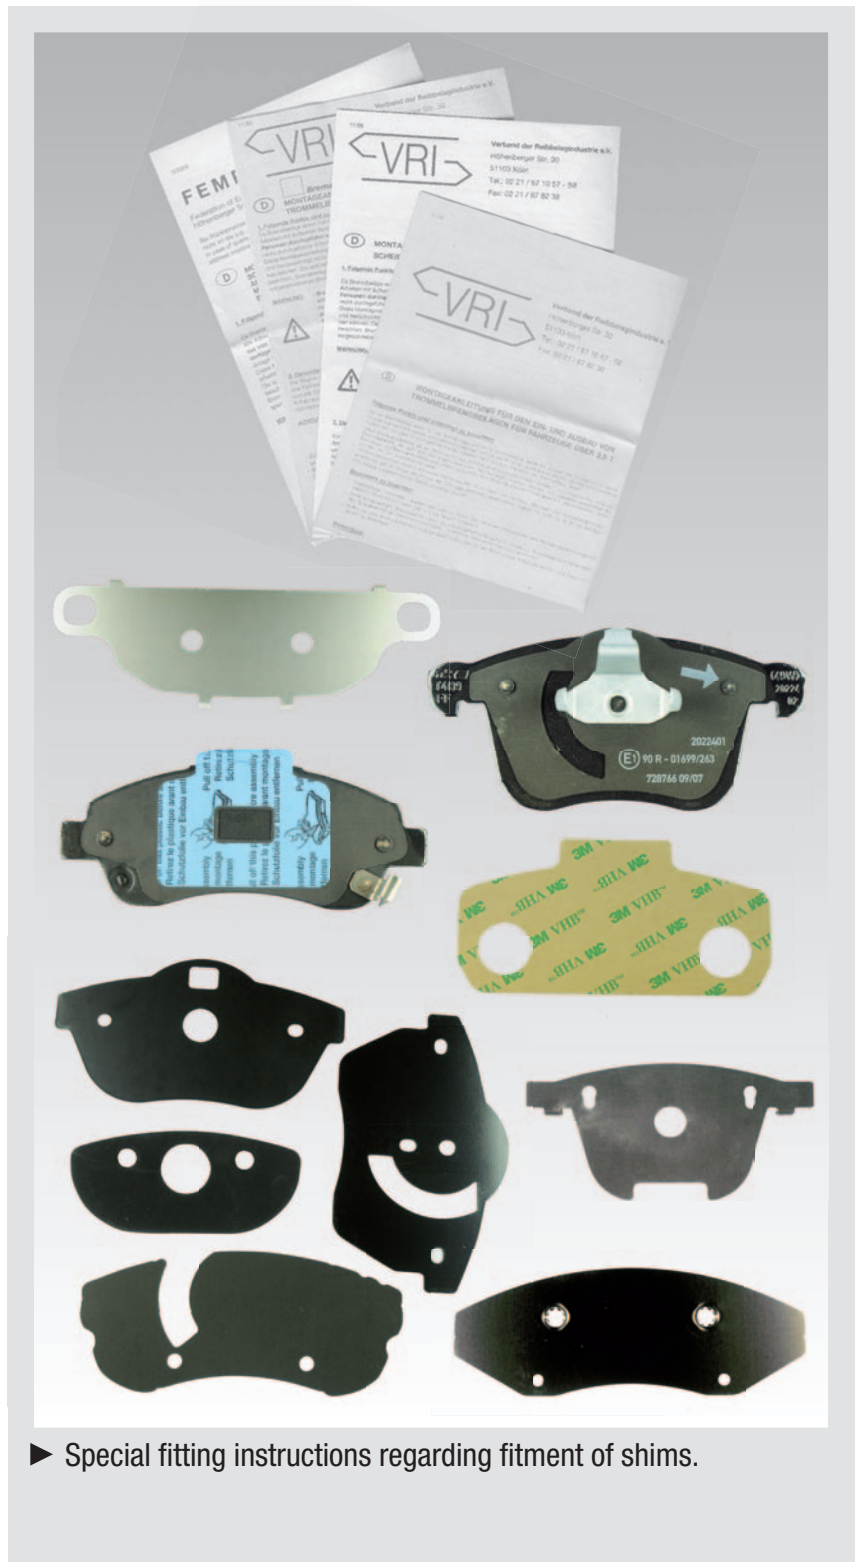
Special fitting instructions regarding fitment of noise reducing components e.g. shims must be followed to prevent noise, judder, disc cracks as well as uneven wear.

► Special fitting instructions regarding fitment of shims.

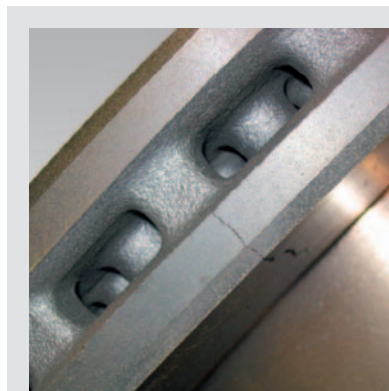
Brake disc worn beyond permissible wear limit.

► Cracked brake disc

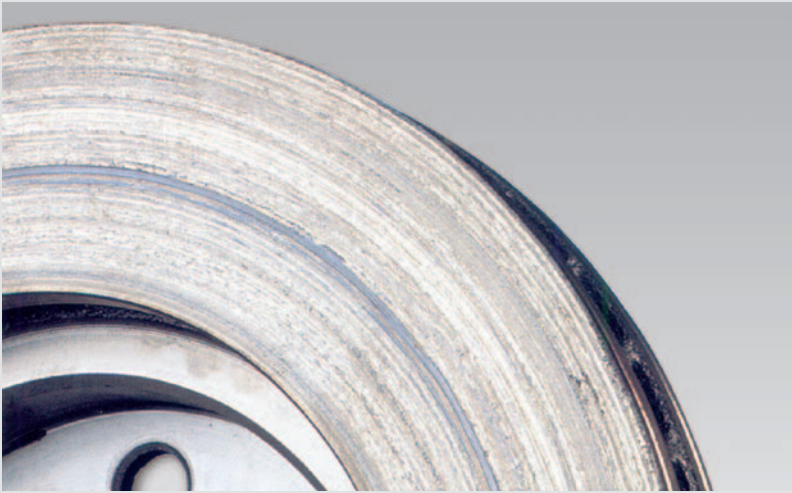
► Brake disc with score marks

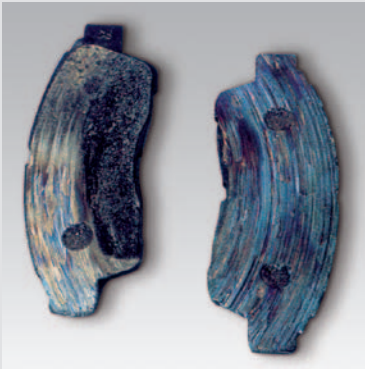
► Friction material worn down to the steel back plate

Brake pads not replaced in time.

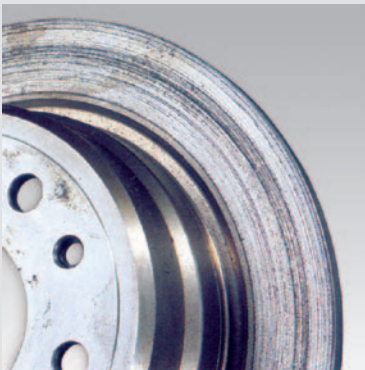
► Brake discs damaged by contact with backplate due to worn out friction material

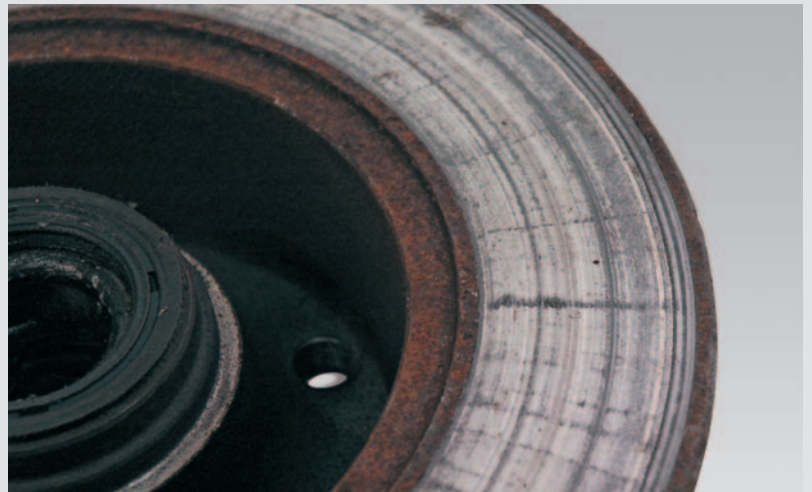
Rough brake, braking noise, signs of judder.

► Corroded brake disc

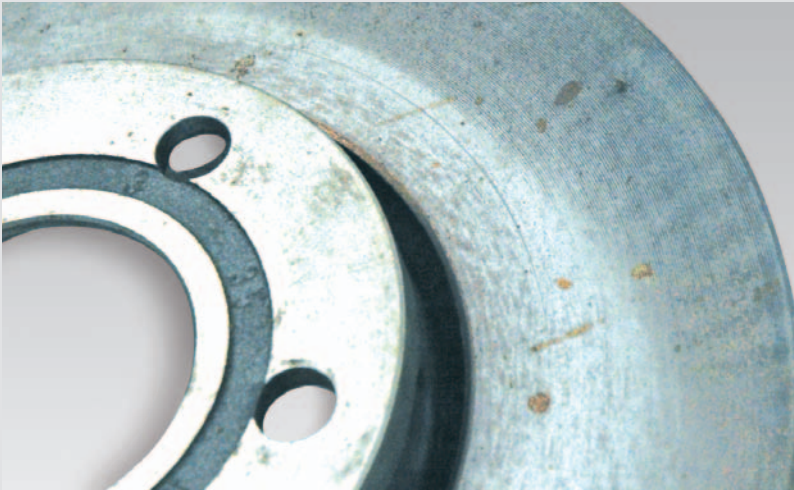
► Disc thickness variation

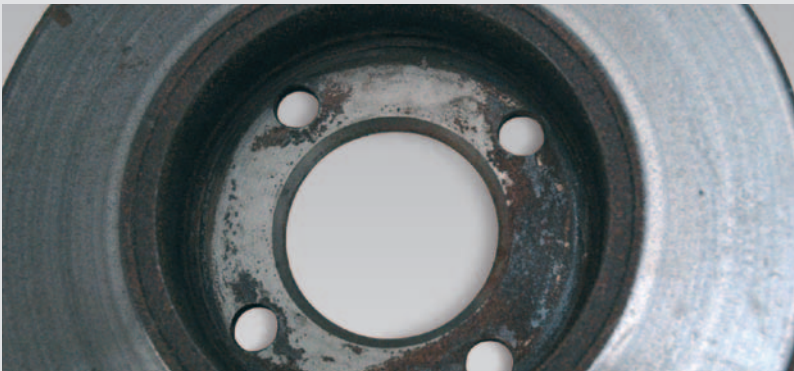
► Heavy underlying corrosion
