2016.0 RANGE ROVER (LG), 501-26

BODY REPAIRS - VEHICLE SPECIFIC INFORMATION AND TOLERANCE CHECKS

TAILGATE ALIGNMENT (G2032472)

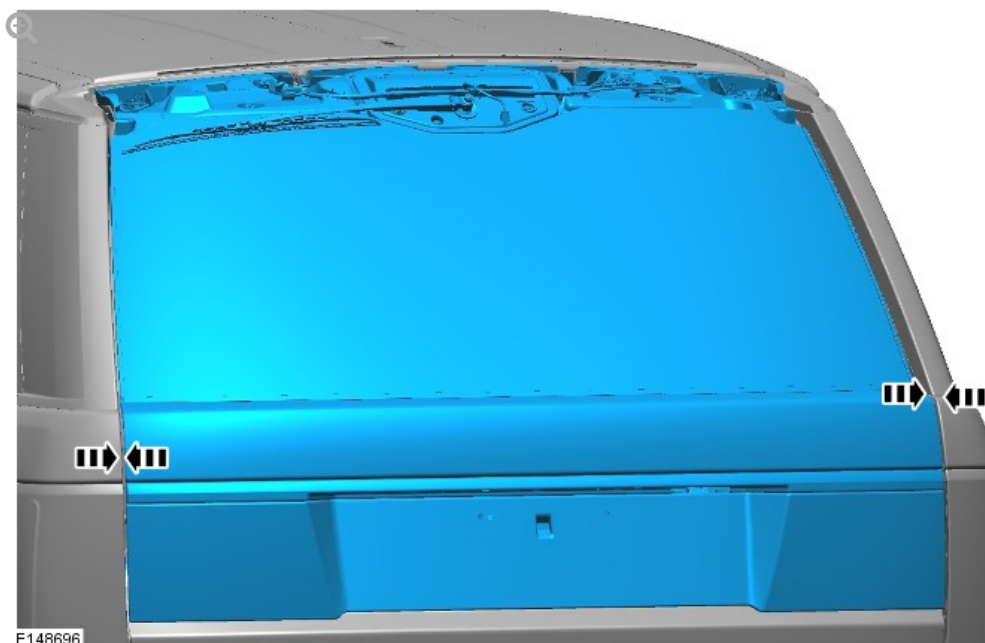
- 2.

With the liftgate closed, check the alignment of the liftgate to the roof panel and body side panel. The liftgate should be central in its aperture.

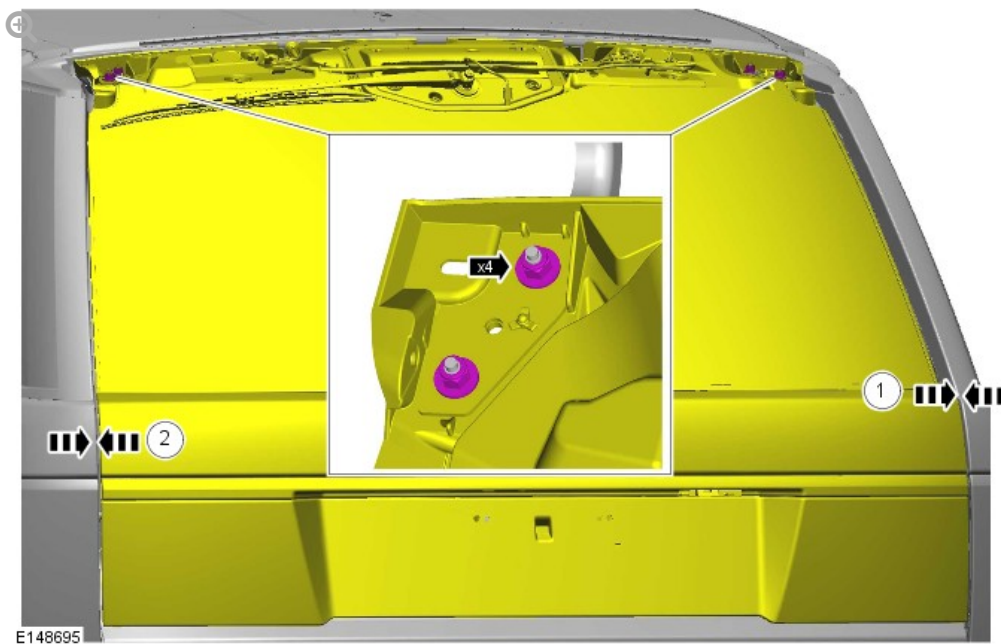
3.

- Make sure that the tailgate is flush with the fender at point 1.
- Make sure that the tailgate is recessed by 1.5 mm in relation to the fender, at point 2.

Loosen, but do not remove the liftgate hinge bolts.

4. Tighten the liftgate hinge bolts.

Torque: 24 Nm
