8 speed shift lock solenoid problems

P176C-11 Transmission range selector lock control error – General electrical Failure – circuit short to ground

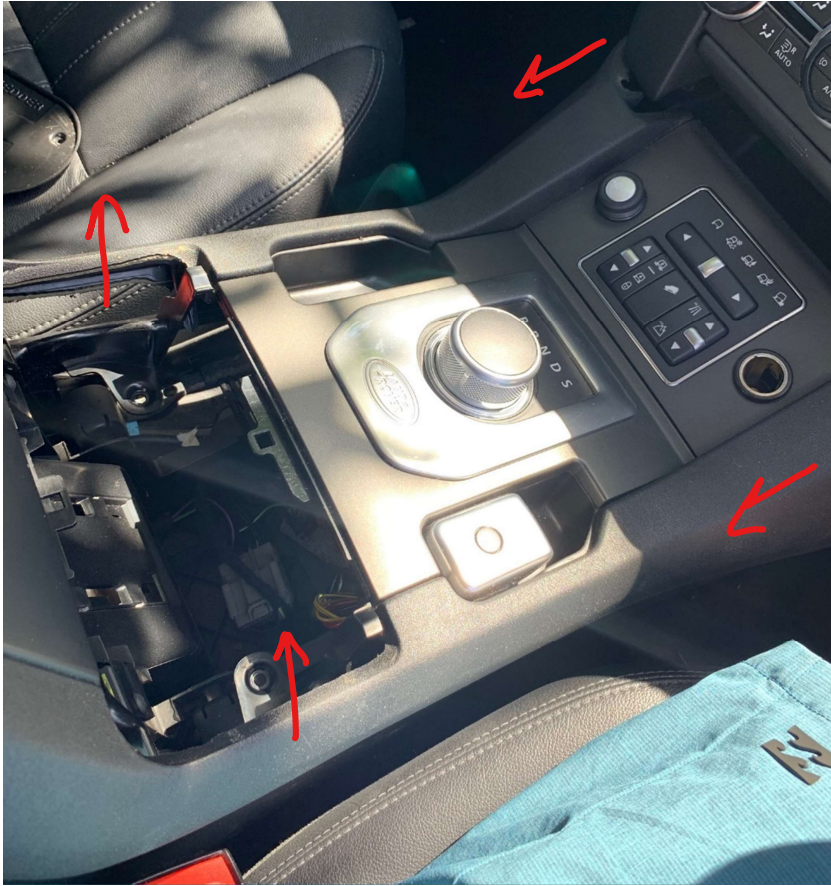
Open up the centre console lid and start pulling up on the sides of the centre console where the cup holder is, the entire centre section surrounding the TCS should lift up and come free. It will slide backwards away from the dash.

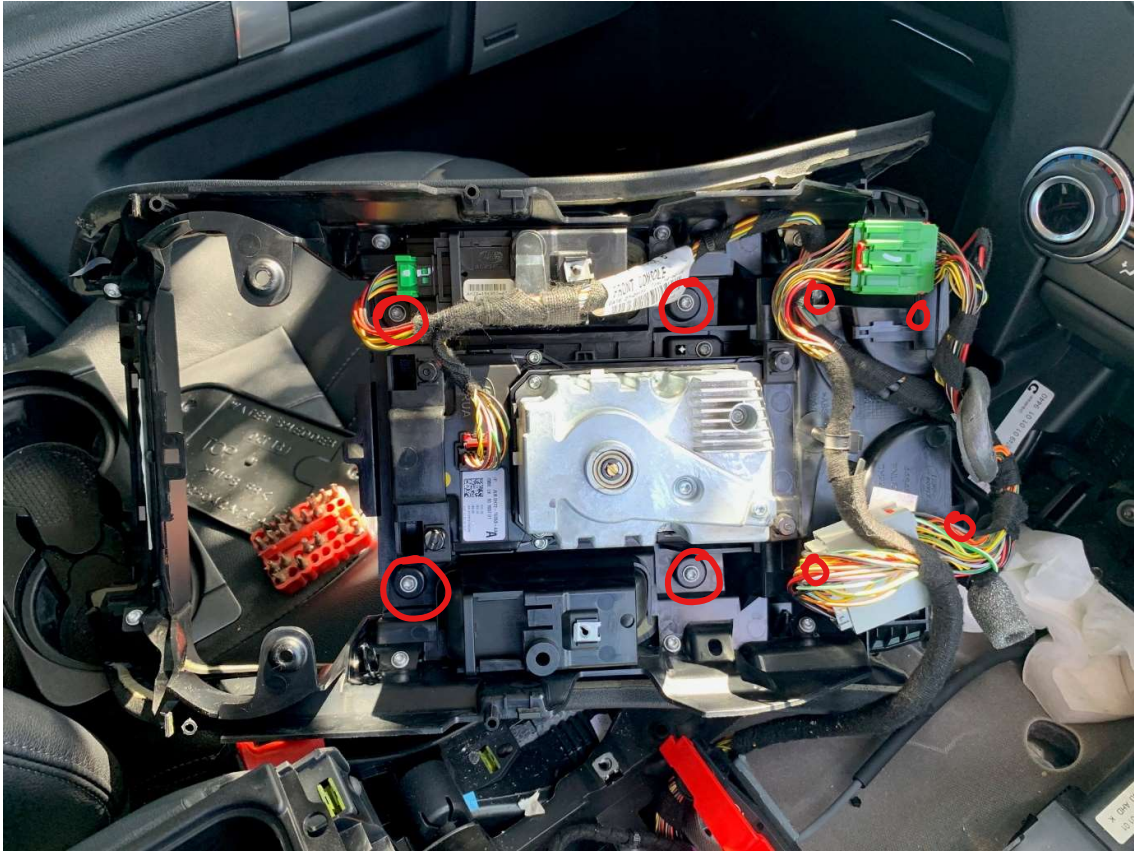
The brass screw at the base of the TSC will raise and lower the rotary dial, it will be very easy to turn, the dial can be used (turned) in the fully lowered AND fully raised position, however do not turn this screw if the dial is not in Park, the dial will attempt to rotate to Park as it is lowered, if your shift lock solenoid is in the locked position (unpowered) and the dial is in anything but Park you will break something.

Using the T20 Torx Driver undo the 4 screws holding on the plastic trim surrounding the TCS, also onto the 4 screws holding on the Mode selection/height/low range switch panel.

Two of the screws are hidden behind the Gray and Green connectors, if you cannot access these screws simply release the connector from its holder BUT don't disconnect the connection itself.

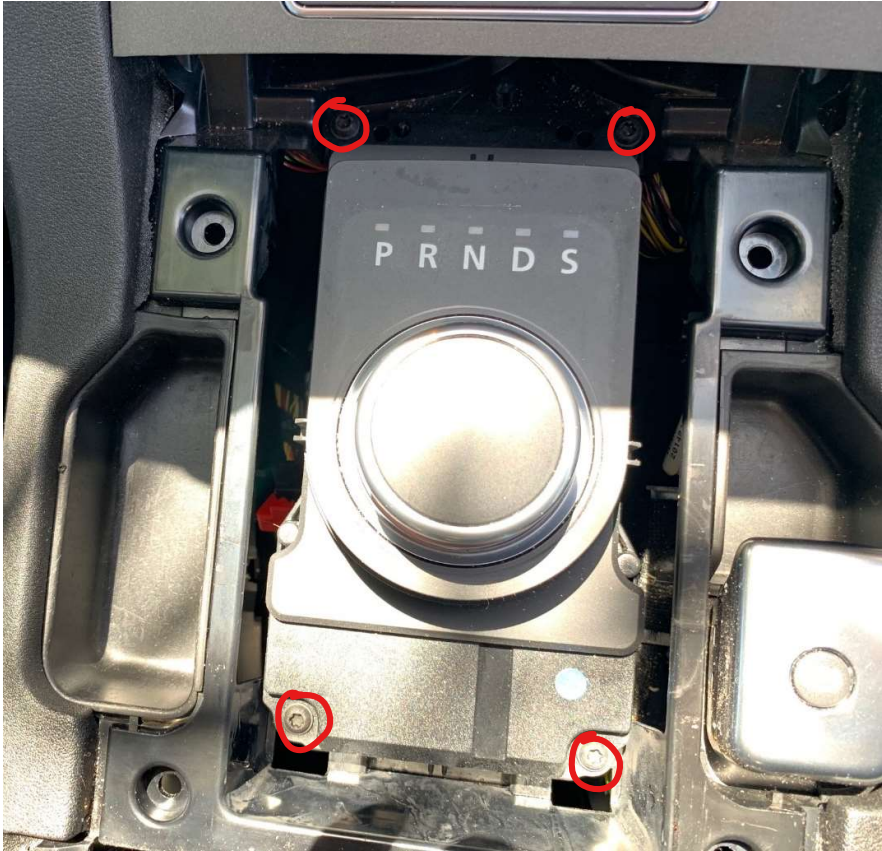
Carefully remove the plastic surround from the TCS, you can gently lift it up from the cup holder side, part of it will sit under the Mode selection/height/low range switch panel.

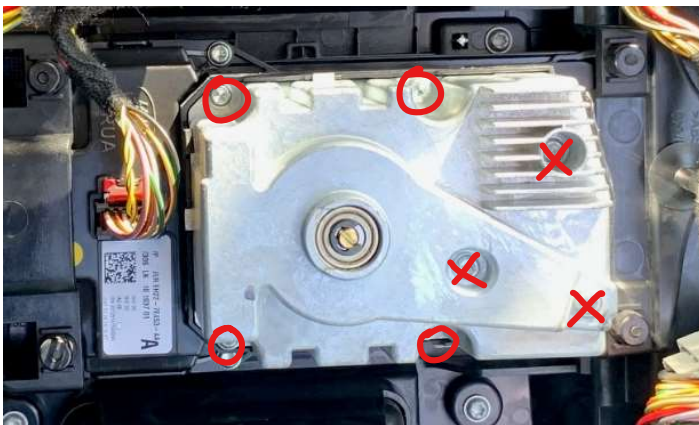
Remove 3 of the 4 screws on the outside edge on the base of the TCS, do not undo the screws in the centre of the unit, they hold the motor and solenoid in place.

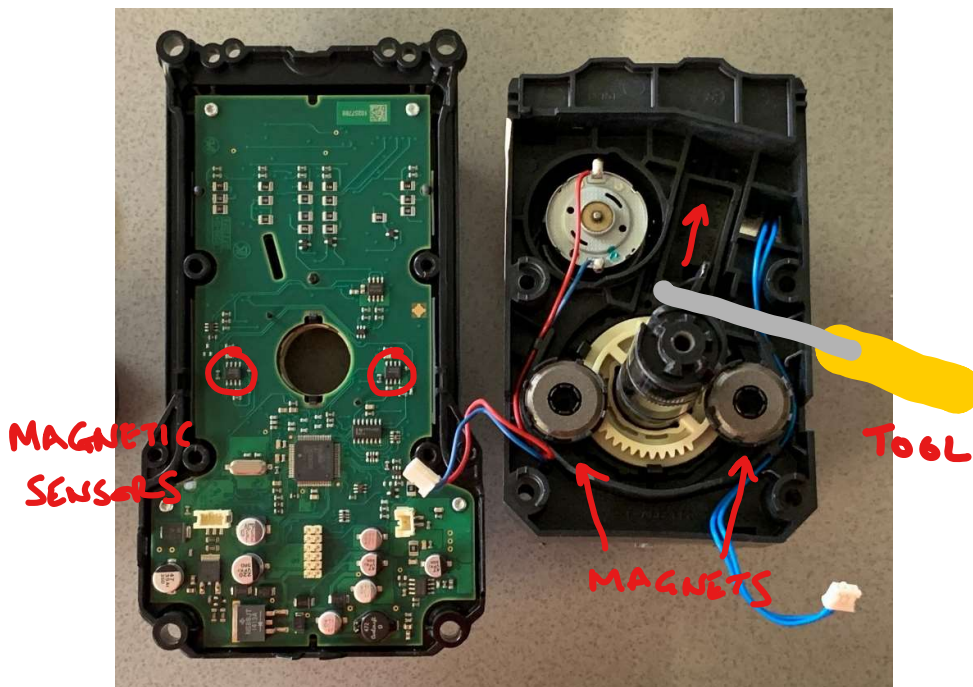
Fully opened view of the TCS (taken during the repair procedure, you don't need to open the unit this far yet)

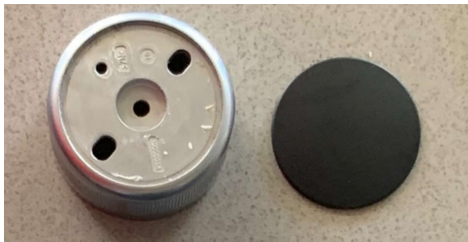
To open the unit fully we will need to remove the black plastic centre cap from the metal dial, the cap is held on with double sided tape, to do this we push a small flat blade screw driver between the edge of the plastic and the metal dial and lever slowly up, I also used a box cutter and pushed the blade into the small gap once it started to lift (be careful if you do), I managed to get this off without any issue but don't worry if you damage the cap as aftermarket replacements are available in a range of colours.

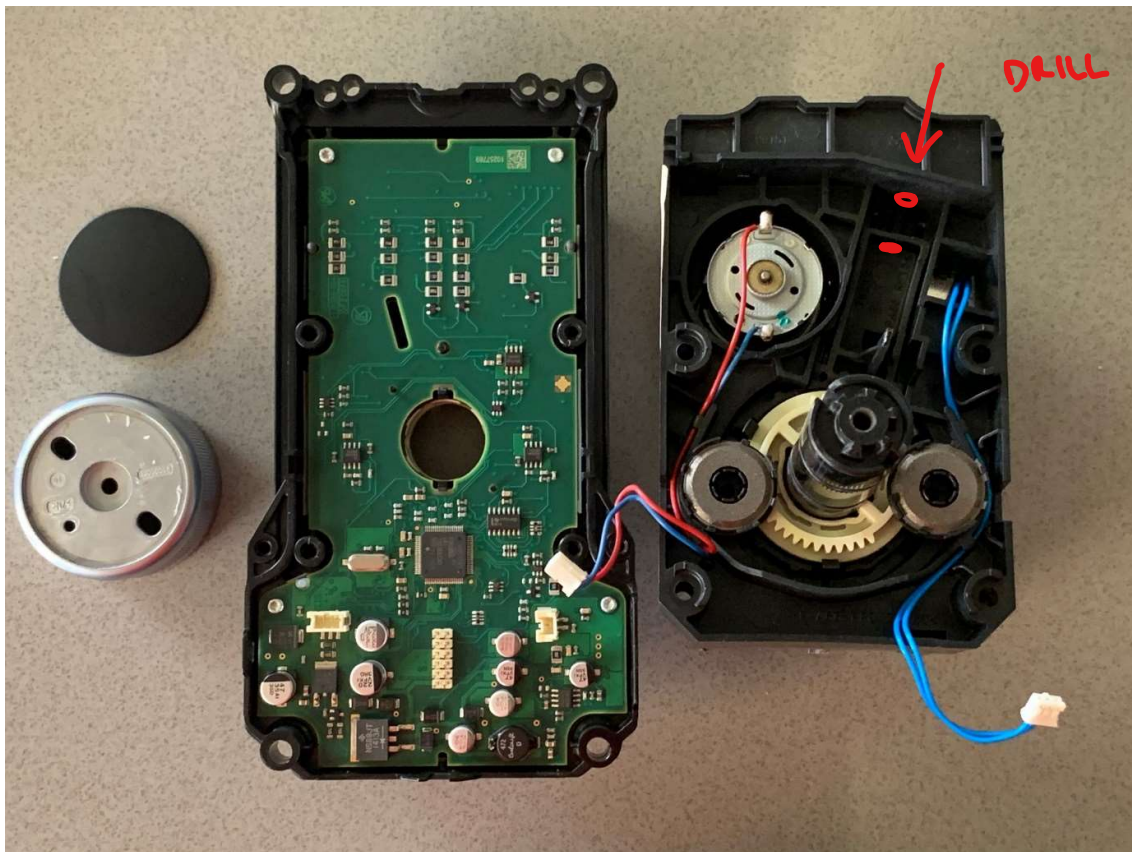
You should now be able to separate the TCS into two halves.

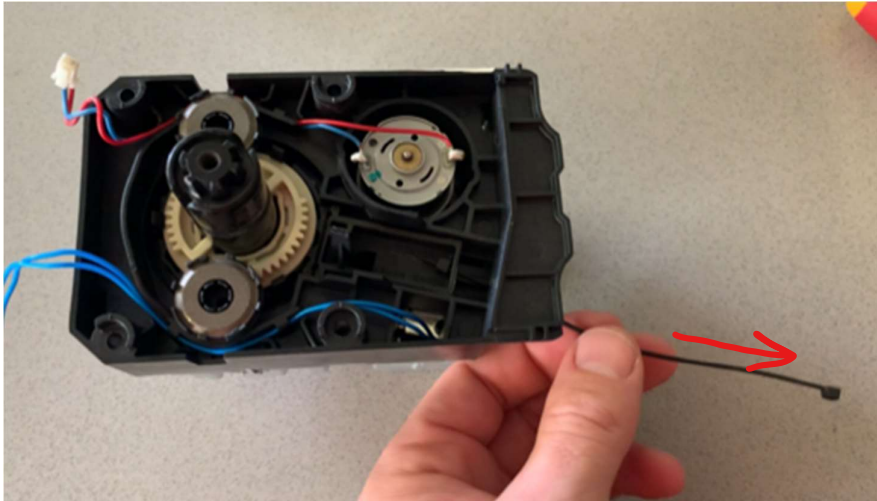
Next we're going to drill a hole into the case and through the end of the plastic locking mechanism, I'm not going to give measurements but you will want the holes to line up and be roughly 3 mm, take your time (measure once and drill twice, or something like that).

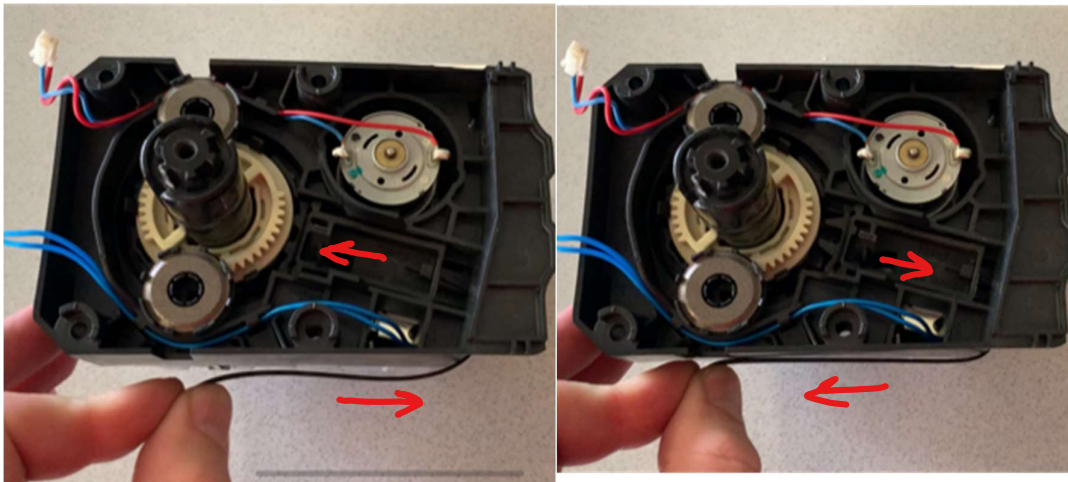
Take a long thin zip tie and loop it around a key ring and zip it up (this will be your ring pull), then thread the other end through the hole and connect a second zip tie to this, cut off the excess zip tie and the rest of the second zip tie. The zip tie is flexible enough to loop around and apply pressure on the mechanism when pulled from the cup holder side of the TCS. This is what I used but you can use string or anything similar on hand, just ensure that the mechanism is free to move when no pressure is applied.

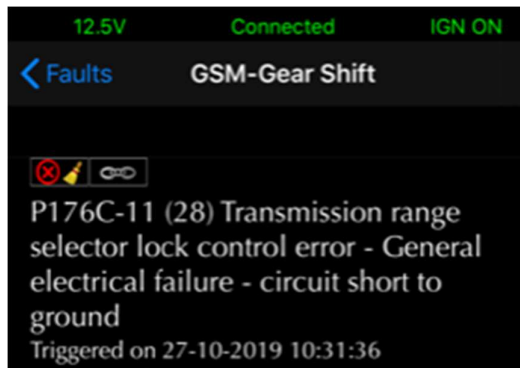
My fault disappeared, I was expecting it to return at some point but I continued to drive on, comfortable that my newly installed shift lock release would keep me going if it did. And a few days later the fault returned.

Again remove the TCS and open it up,

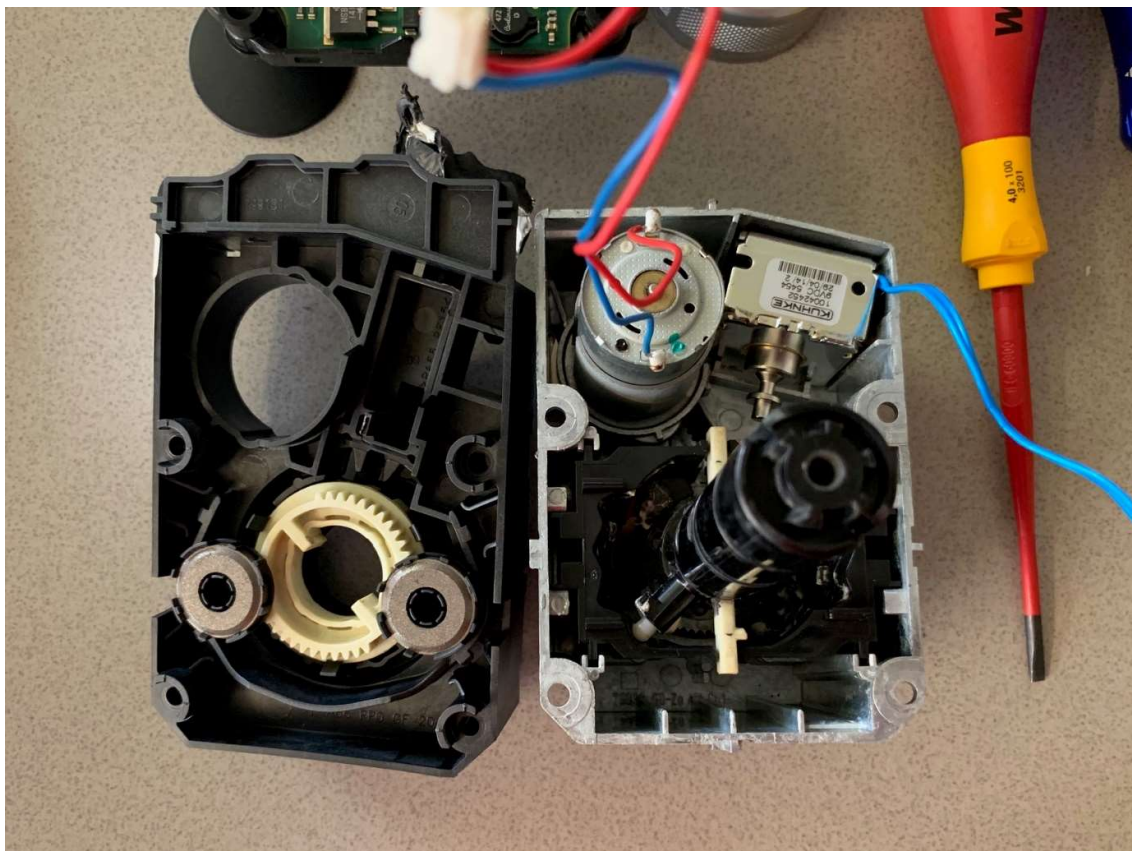
Optional Step if you wish to remove the solenoid, it is possible to test without removing it; we will need to remove the silver foil sticky black sticker thing that is attached to the front of the TCS (Alternatively cut through the middle of the foil where the plastic meets the metal). Then you can separate the lower section of the TCS into two (we now have three parts Top - printed circuit, Centre - Magnets and shift lock, & The Lower Metal with the raise / lower motor & shift lock solenoid).

Note; Careful not to pull out the main shaft as parts may fly out and we need them all in to work

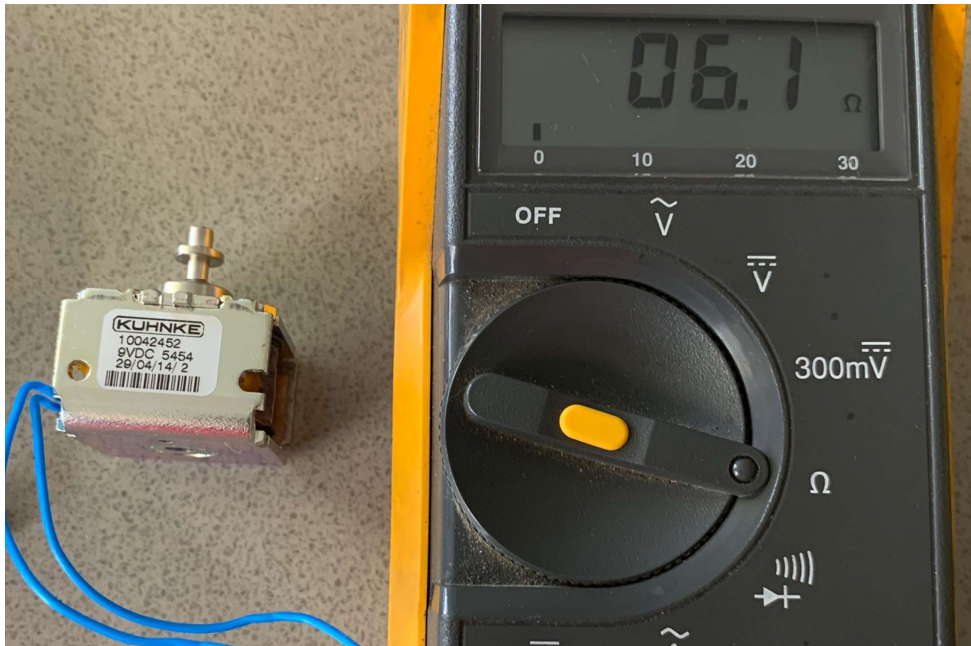
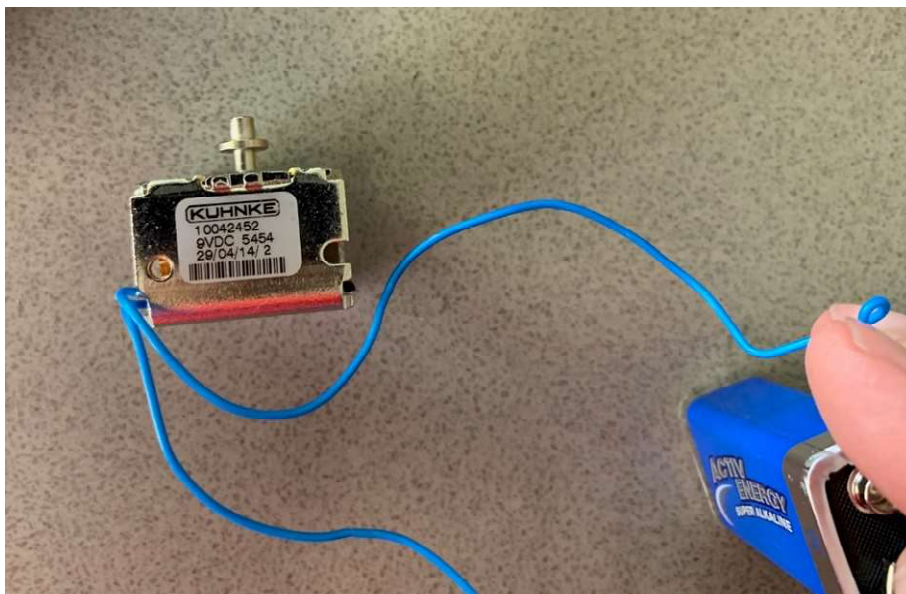
Firstly, I tested the shift lock solenoid itself, It's rated at 9 volts and I measured the resistance at 6.1 Ohms, using a 9 volt battery it was clear that my solenoid works.

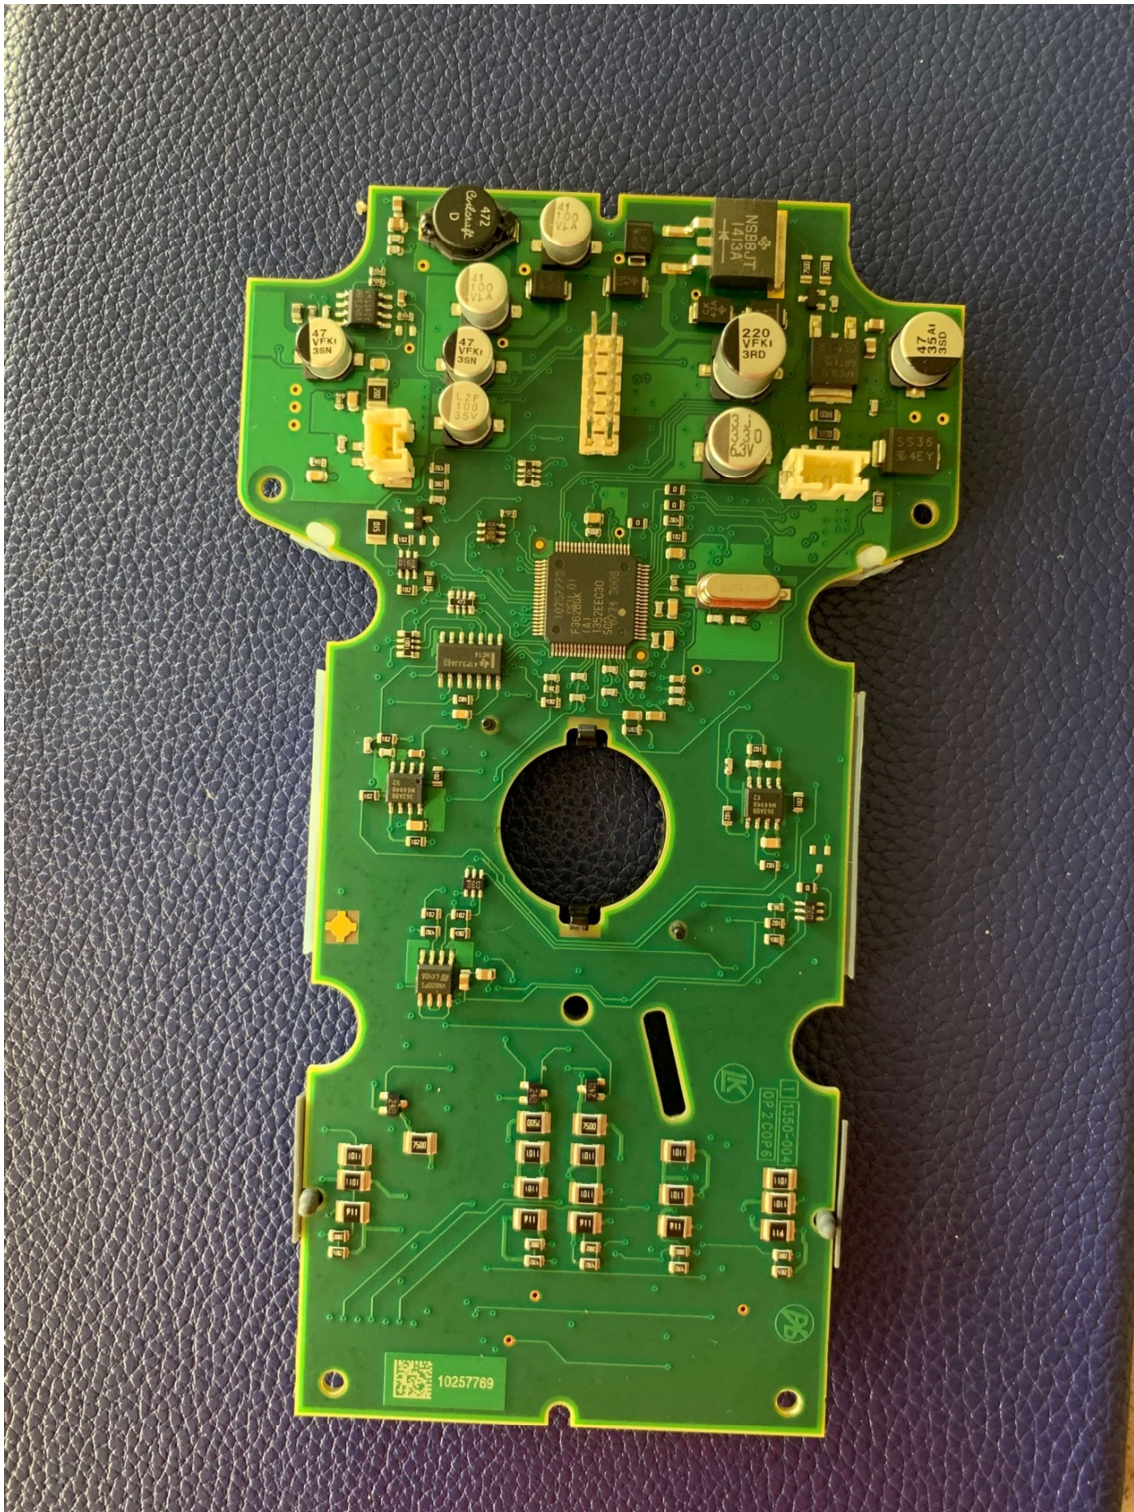
Circuit Board

From here I inspected the printed circuit board with a microscope looking for damage or cracked solder joints, I found nothing, everything looked good except for a slight burn mark on a 1 Ohm resistor. I decided to re-solder several components next to the solenoid connector, you will need a

good quality, small tip, high temperature soldering iron (mine was set at 420°C+), most solders used on modern circuits have little or no lead which makes them harder to work with.

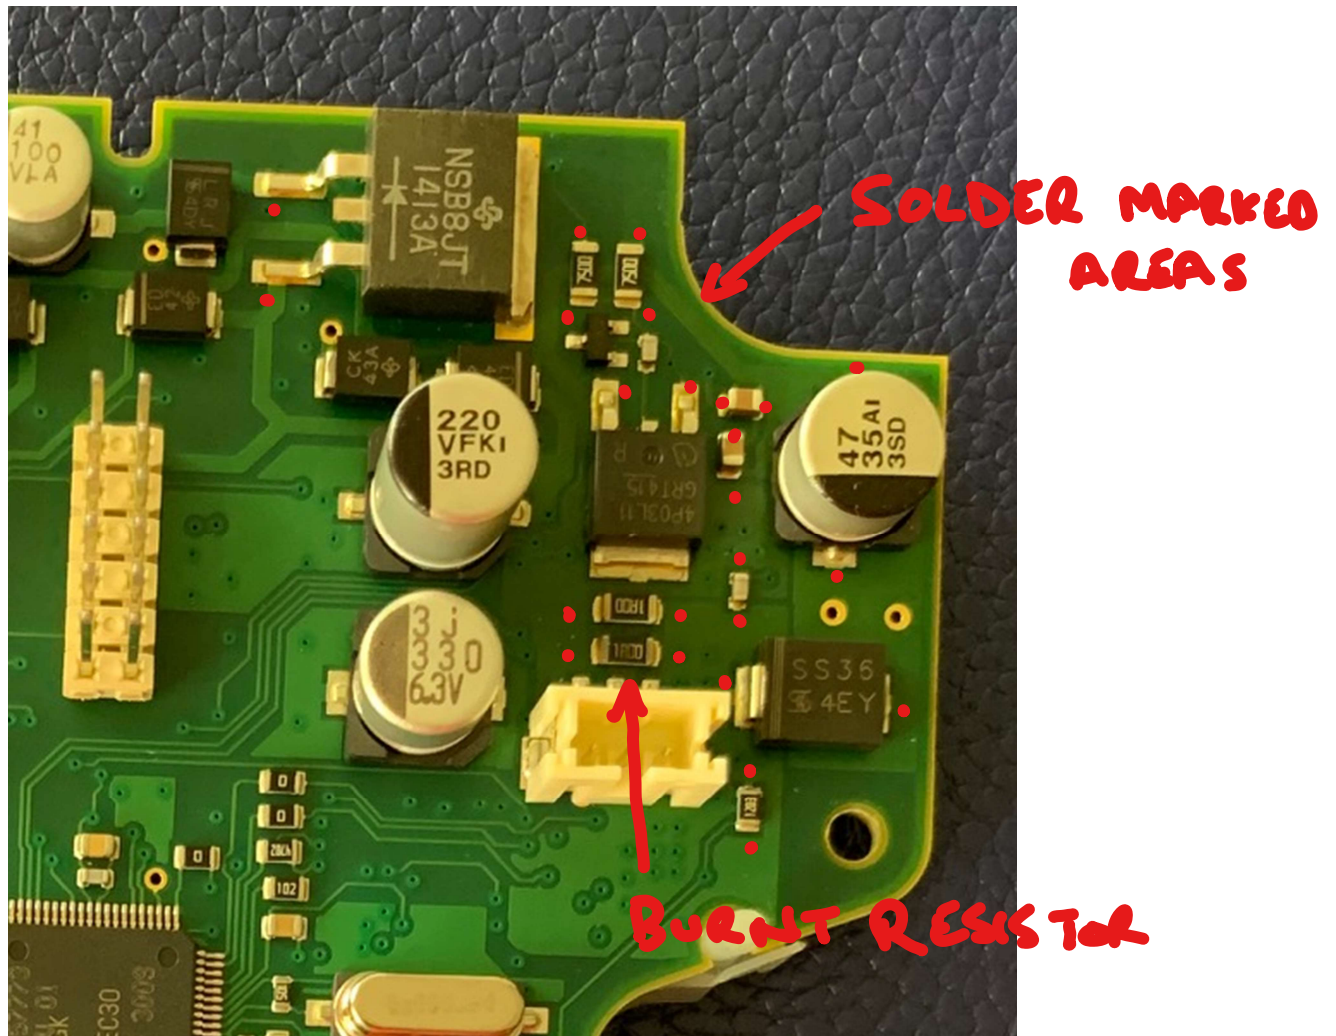
Burned Resistor marked 1R00 and area of interest.

After re soldering, my TCS has worked continuously and I still have my lock release if needed.
