DIESEL EXHAUST FLUID (DEF) QUALITY CONCERN

DIESEL EXHAUST FLUID (DEF) QUALITY PINPOINT TESTS

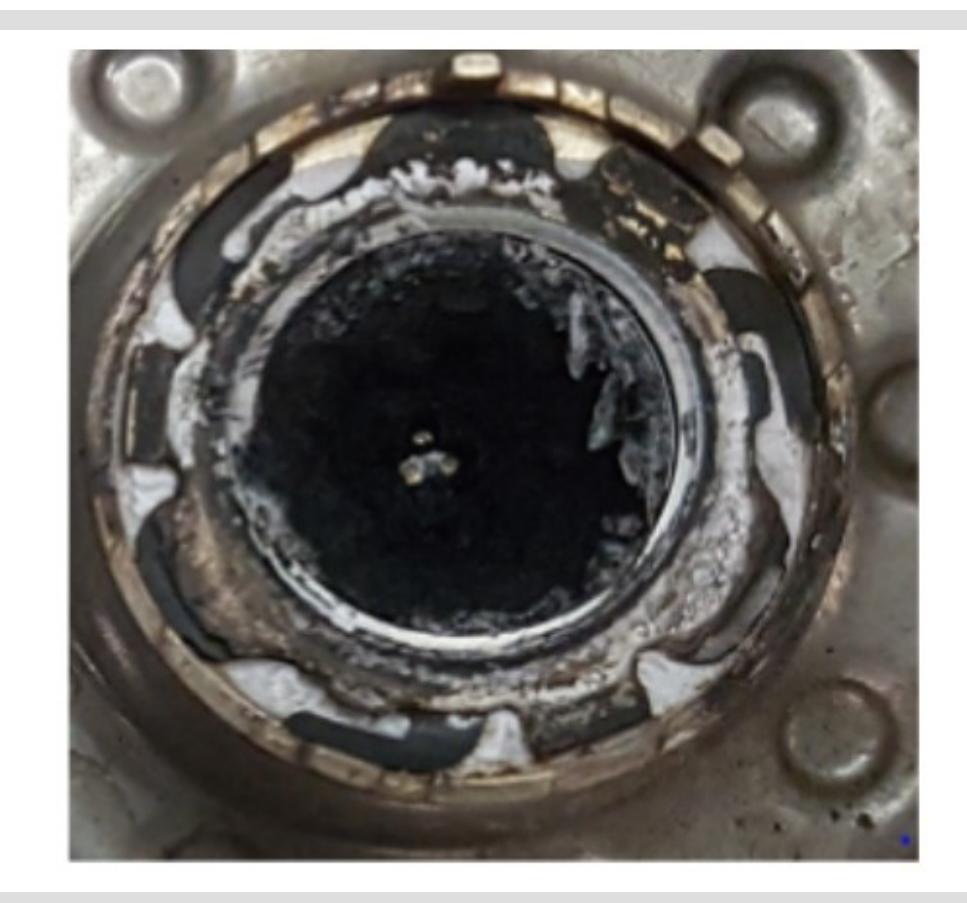
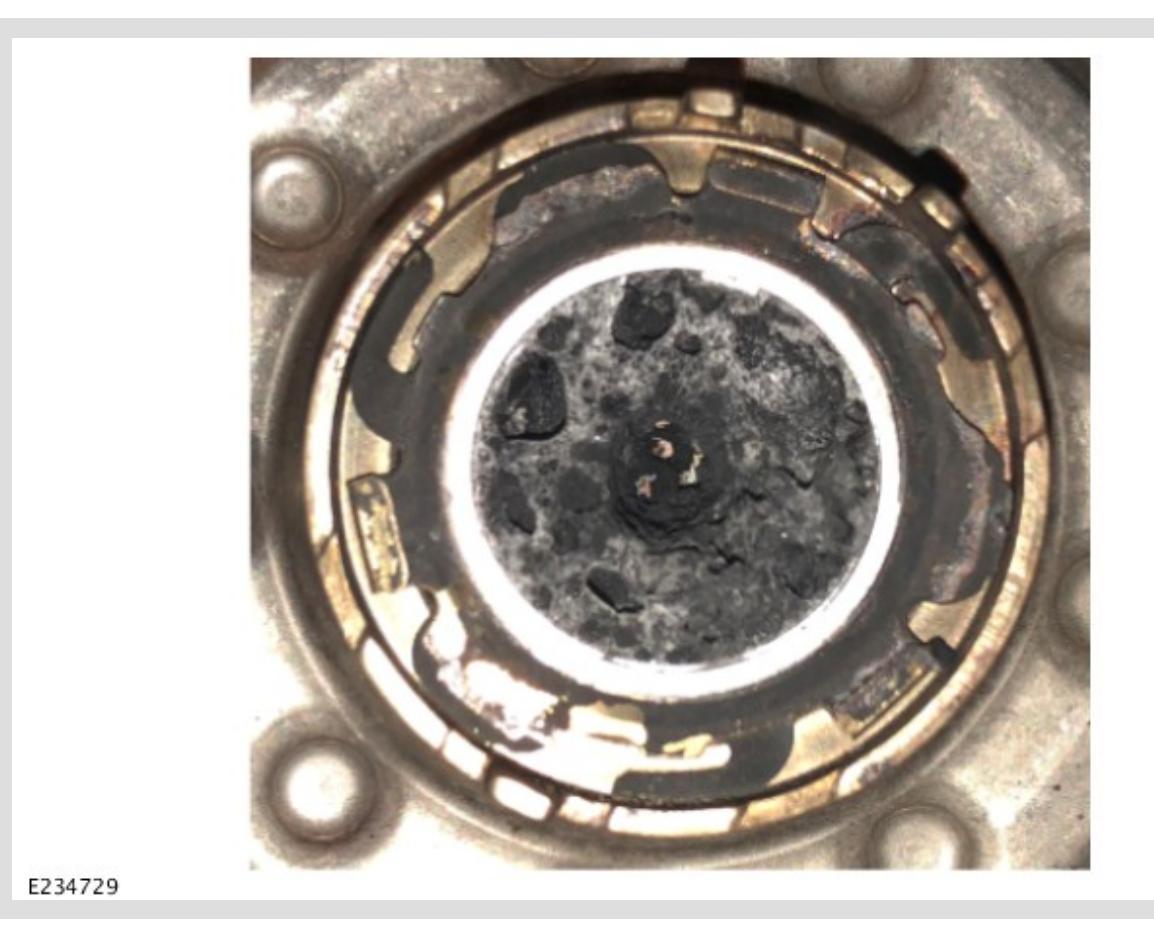
E234728

A visual inspection of the Dosing Module face can be completed. If the 3 injector holes can be seen in the center of the DM then it can be refitted. The soot will naturally clean off at the next DPF Regen cycle. The level of soot seen will vary depending on at which point the vehicle is within the regeneration cycle

DEF DOSING MODULE INSPECTION
